# UNITED FIRST PARISH CHURCH (UNITARIAN)

Quincy, Massachusetts

**HISTORIC STRUCTURE REPORT**

April 1996

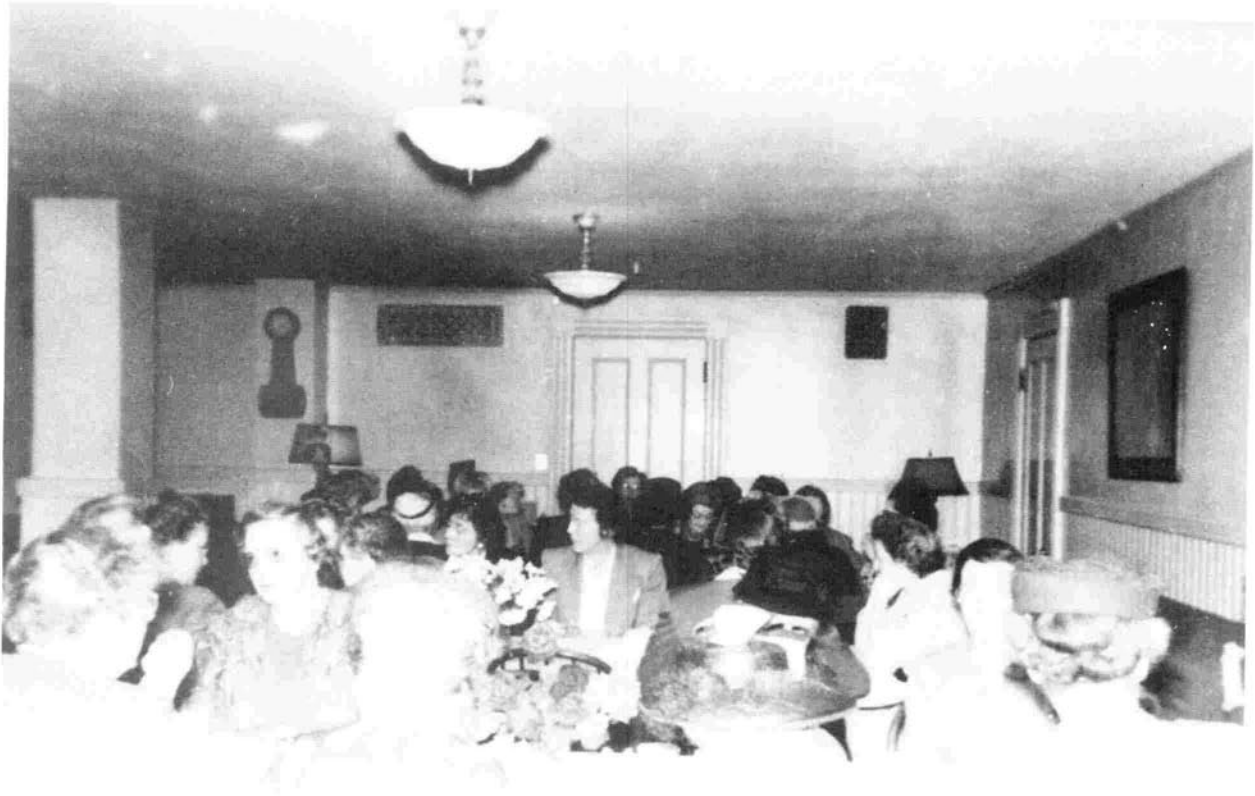
Much of the work done in 1923-1924 is still evident today. Based on the bill and the estimate, it included the following alterations: the decorative painting in the sanctuary was washed off and painted over, the walls were textured, the iron posts supporting the galleries were either encased or replaced, the fretwork along the bottom of the paneled gallery balustrade was changed to dentil work, and the brown linoleum was installed. They also provide other clues about window treatments, pulpit hangings, and floor treatments for the period, including reuse of items. One proposal that probably was not carried out was the installation of a lighting fixture at the center of the ceiling. However, "black iron" fixtures (fig. 46) were installed on the face of the gallery balustrade.

Figure 46. Sanctuary lighting fixture installed in 1923.

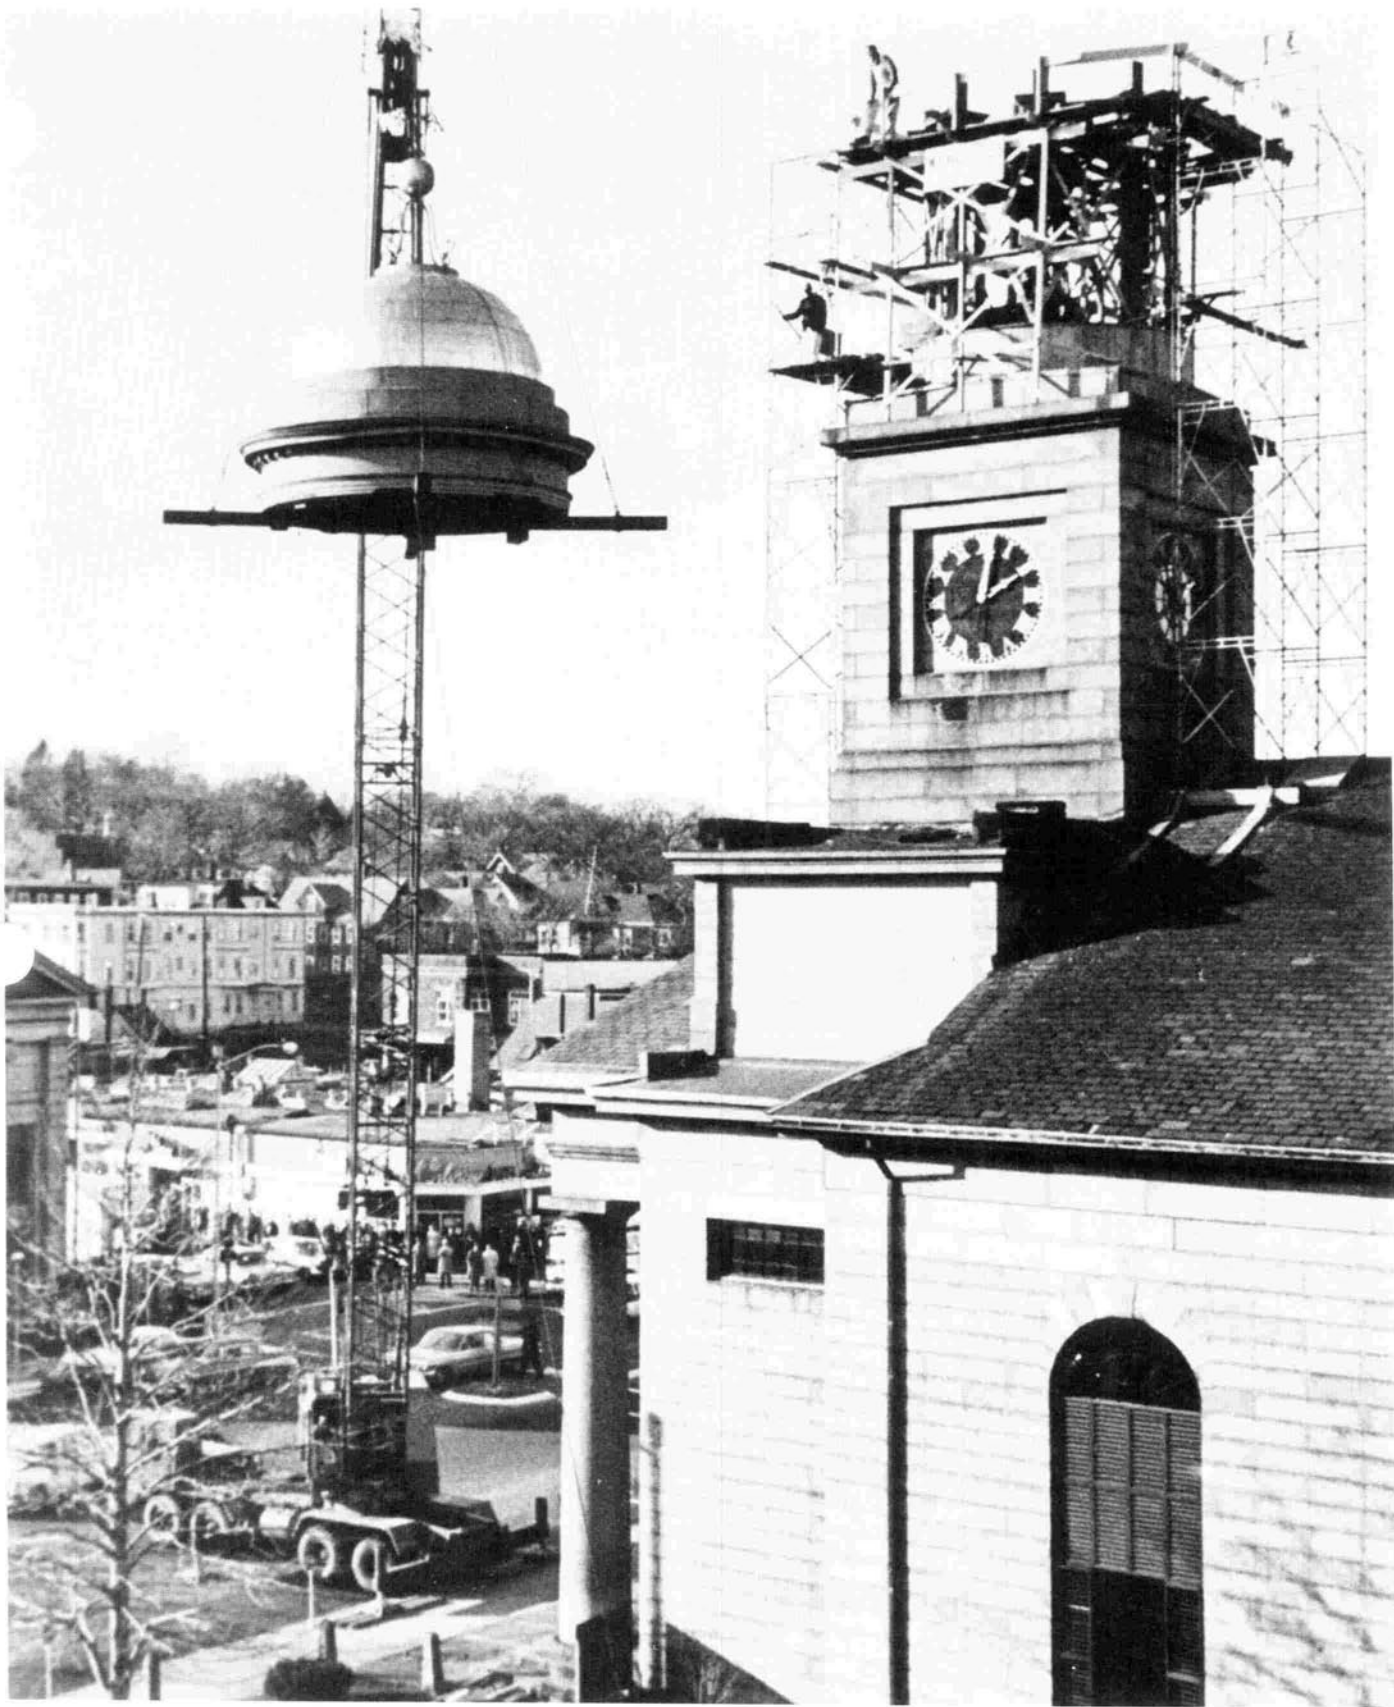
The church committee agreed to follow their suggestion.<sup>496</sup> MacLeod submitted a proposal to the engineering firm, outlining the removal of the dome, the placement of it on staging at least 6 feet above the ground (see figure 48), and the procedure for removing the wood columns and capitals.<sup>497</sup>

Figure 48. Belfry repairs and dome removal (photograph ca. 1964).

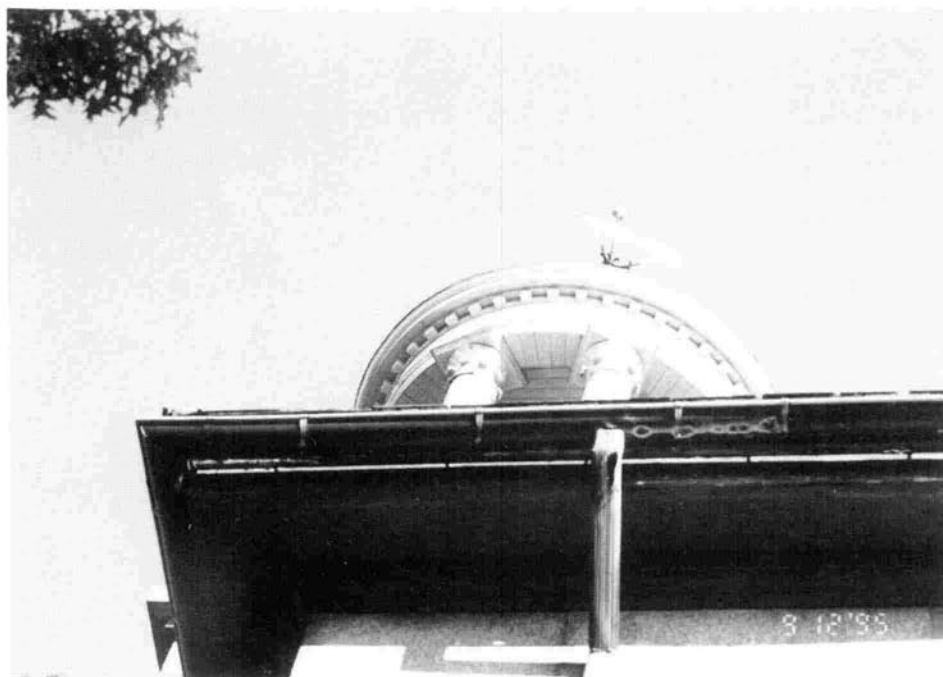
**Figure 75.** Church exterior: southwest corner of roof, showing hanging half-round copper gutter and rectangular downspout, with oxidation and pitting of the copper.

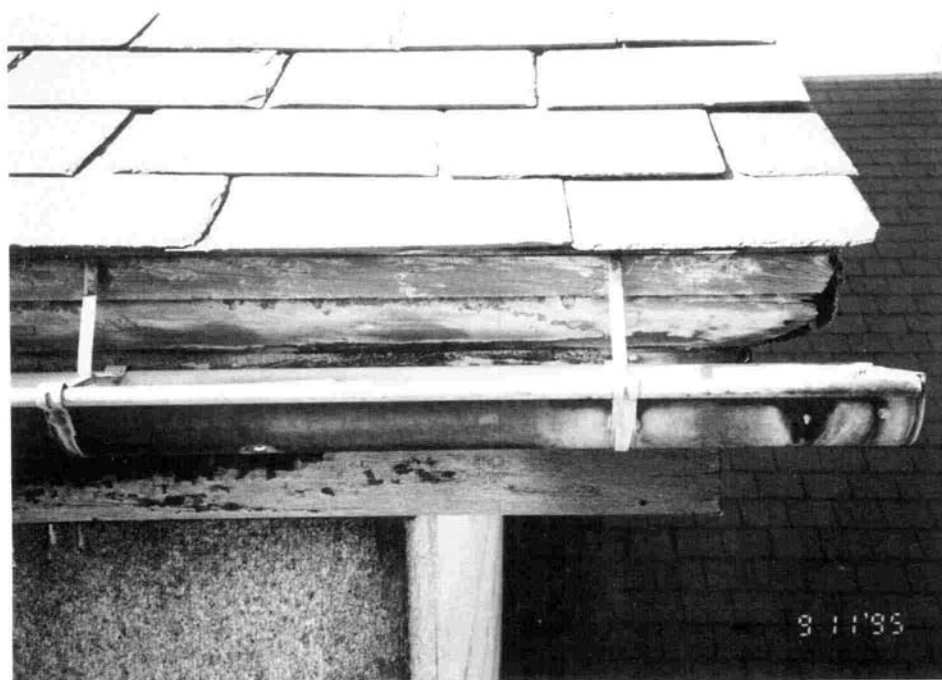
**Figure 76.** Church exterior: southeast corner of the roof, showing hanging half-round copper gutter with oxidation and pitting, and peeling paint and open joints of the wooden cornice moldings.

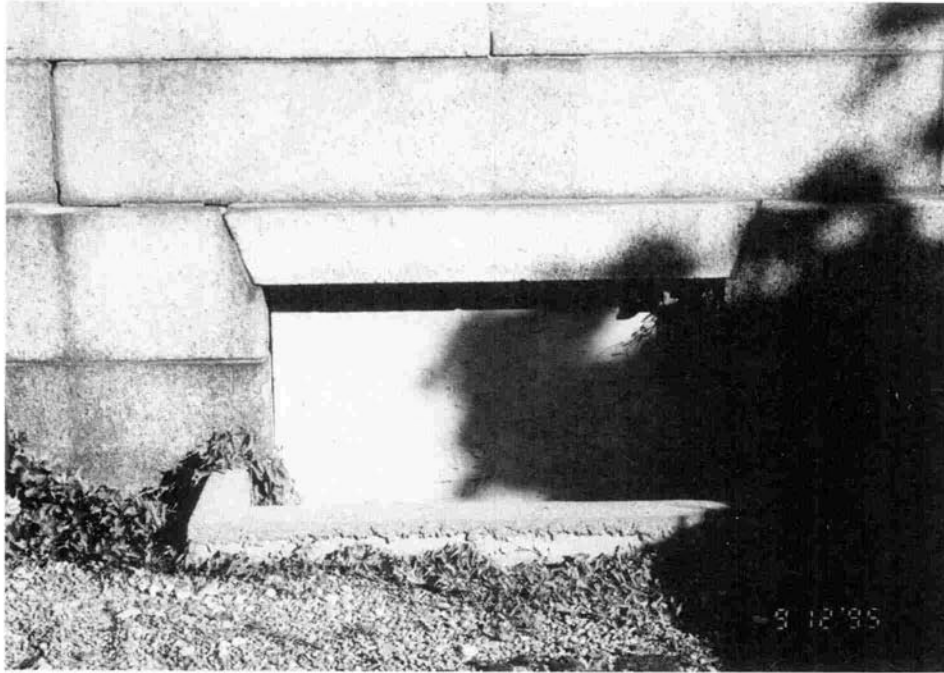
**Figure 87.** Church exterior: south wall, center basement window (W003).

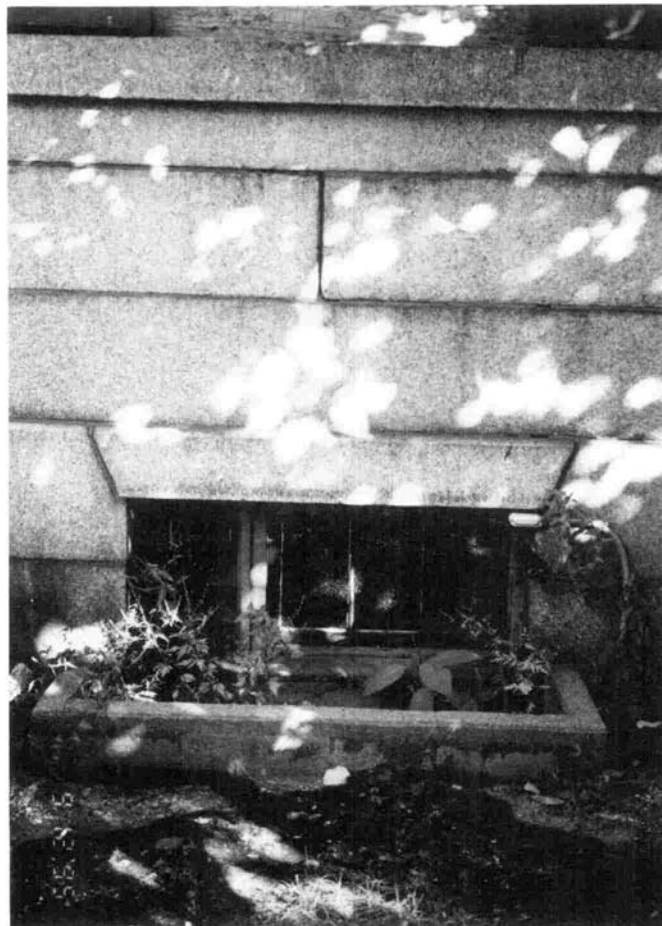
**Figure 88.** Church exterior: south wall, basement window (W004).

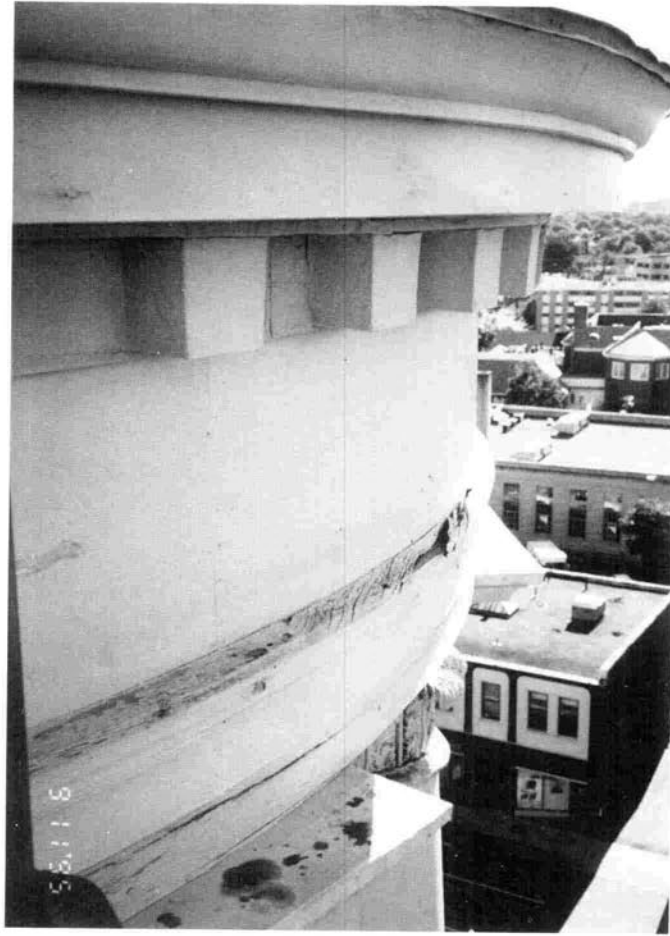
**Figure 91.** Tower exterior: belfry, modillioned cornice.

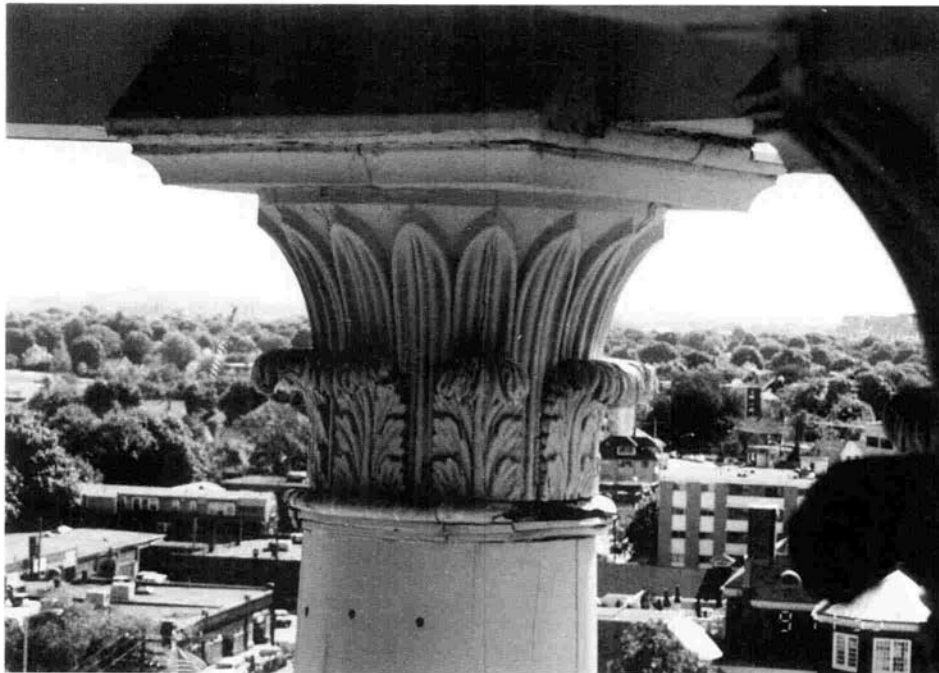
**Figure 92.** Tower exterior: belfry, capital of southeast column.

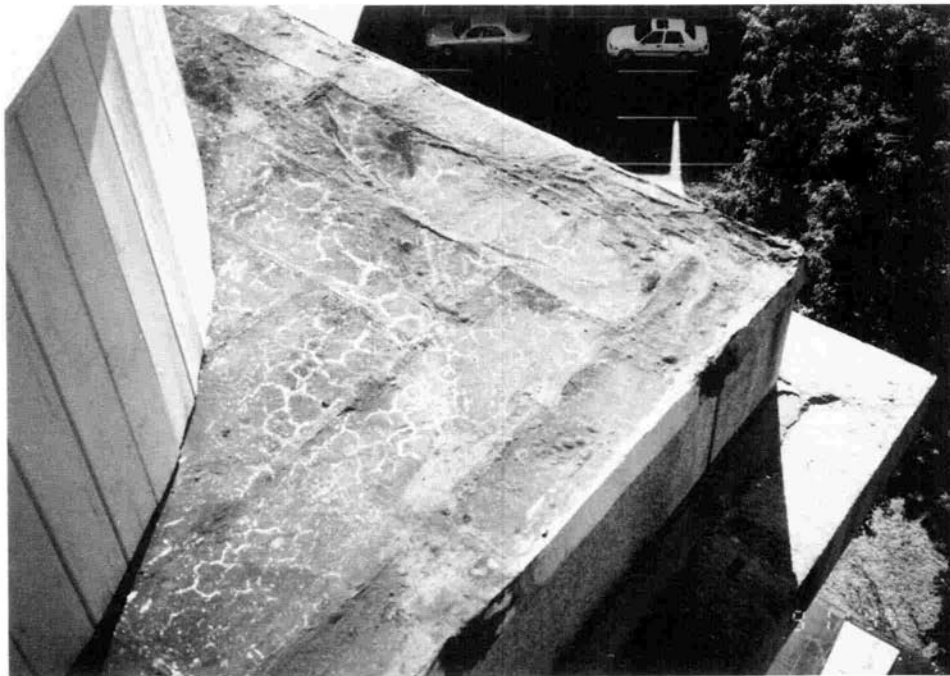
**Figure 93.** Tower exterior: belfry drum and roof of shaft at southwest corner. Roof of bituminous asphalt over flat-seam copper now weathered, dry, and brittle.

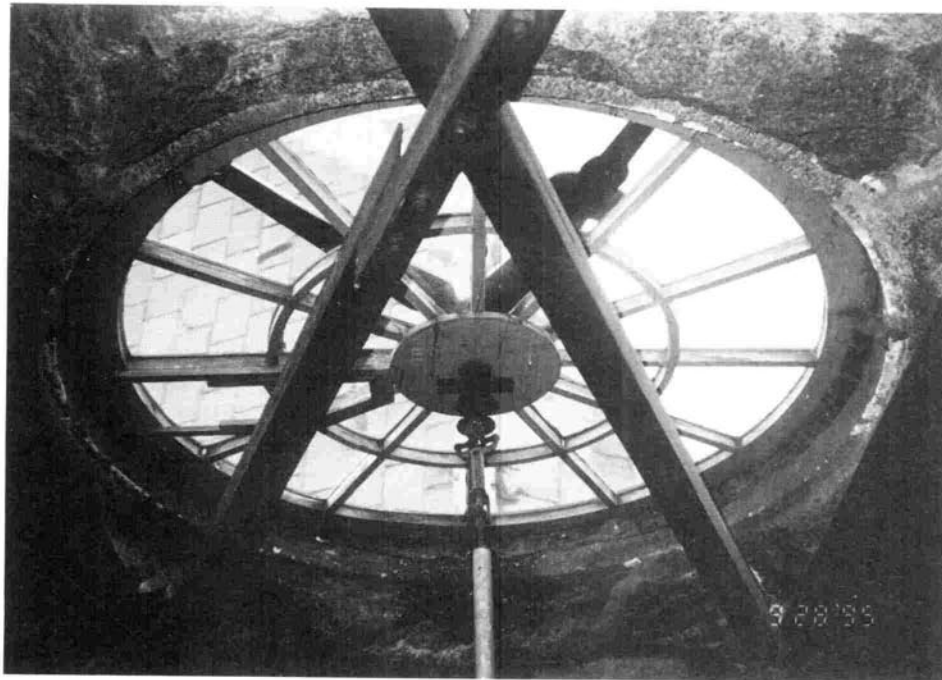
**Figure 96.** Tower interior: shaft, east clock face. Note lack of maintenance of wood elements, and modern interior tower support in foreground.

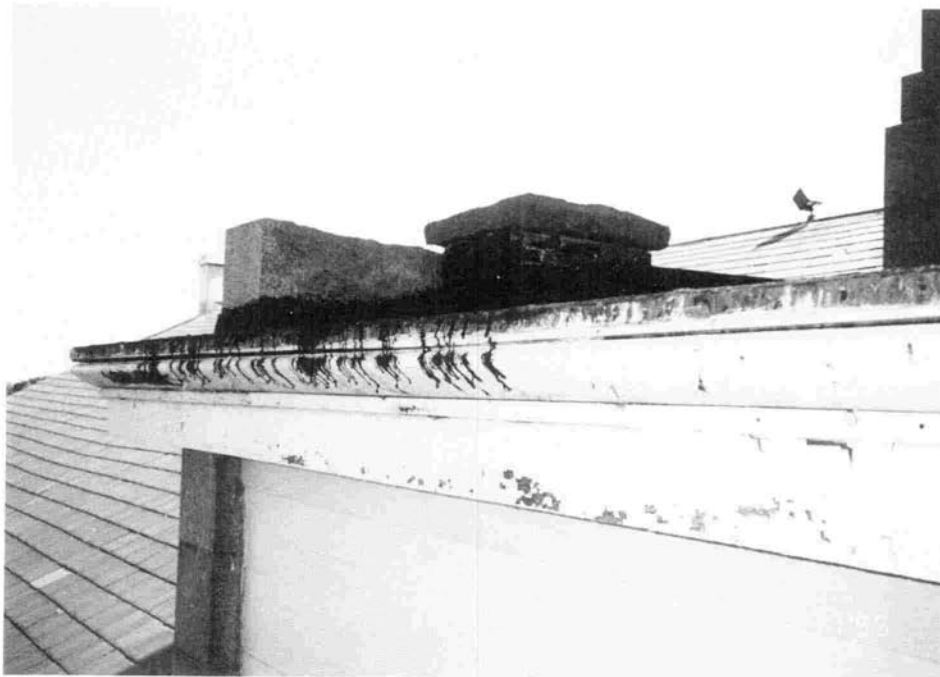
**Figure 97.** Tower exterior: base, cornice of north side of roof. Note careless application of bituminous asphalt over flat-seamed copper roof, and typical lack of maintenance of inaccessible areas.

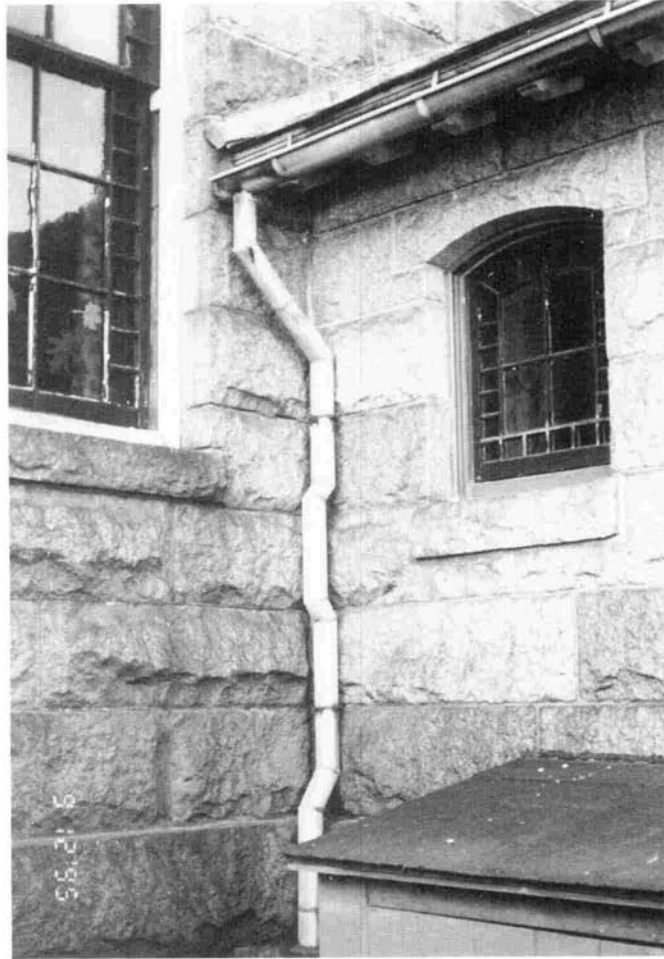
**Figure 105.** Addition exterior: intersection of north wall and north porch, showing gutter and downspout.

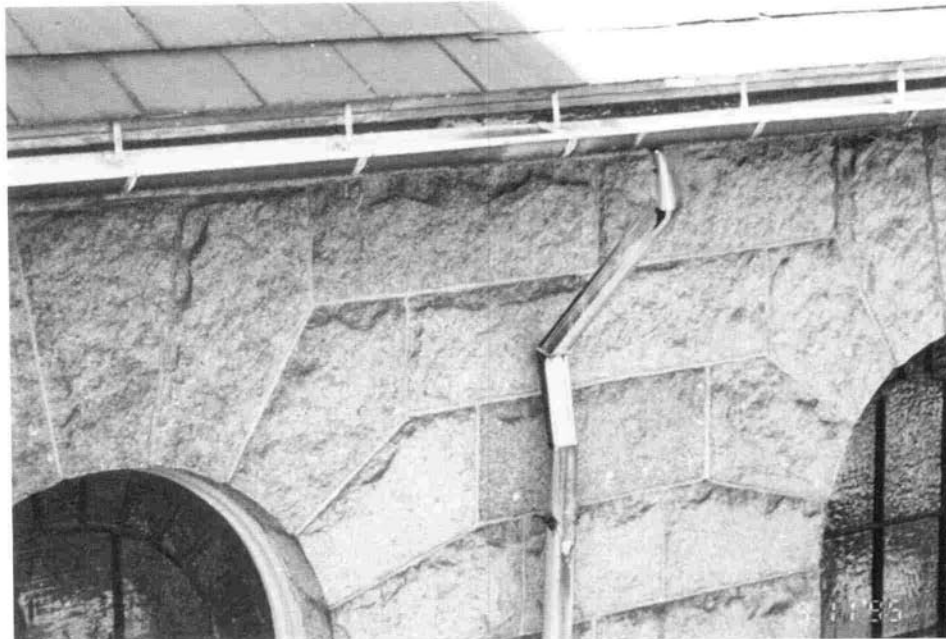
**Figure 106.** Addition exterior: north wall, gutter and downspout.

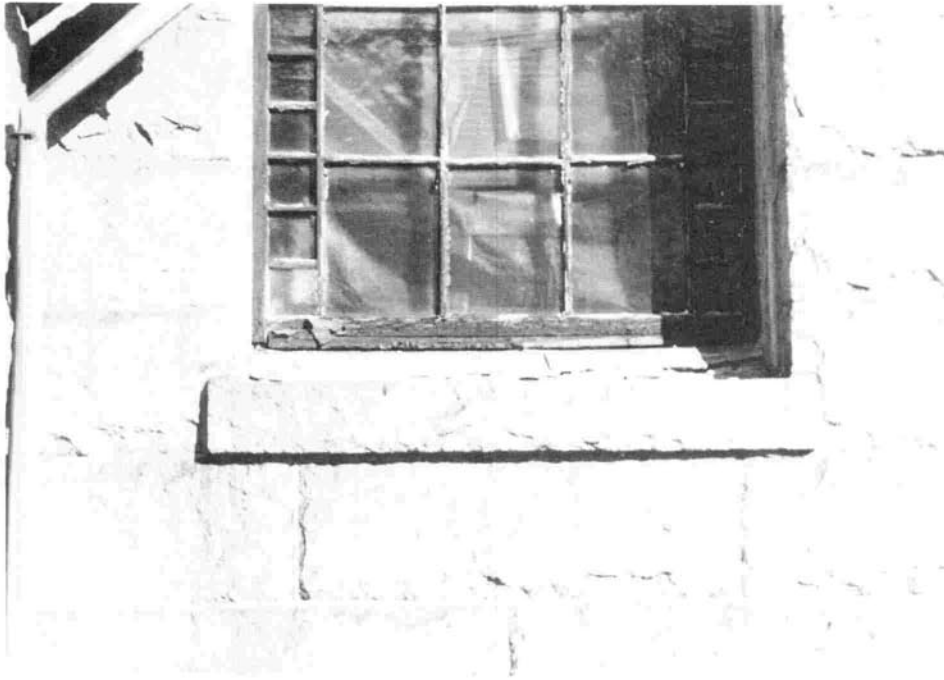
**Figure 107.** Addition exterior: south wall, bottom of center window (W108).  
Note dry wood, peeling paint, and open joints of both sash and surround.

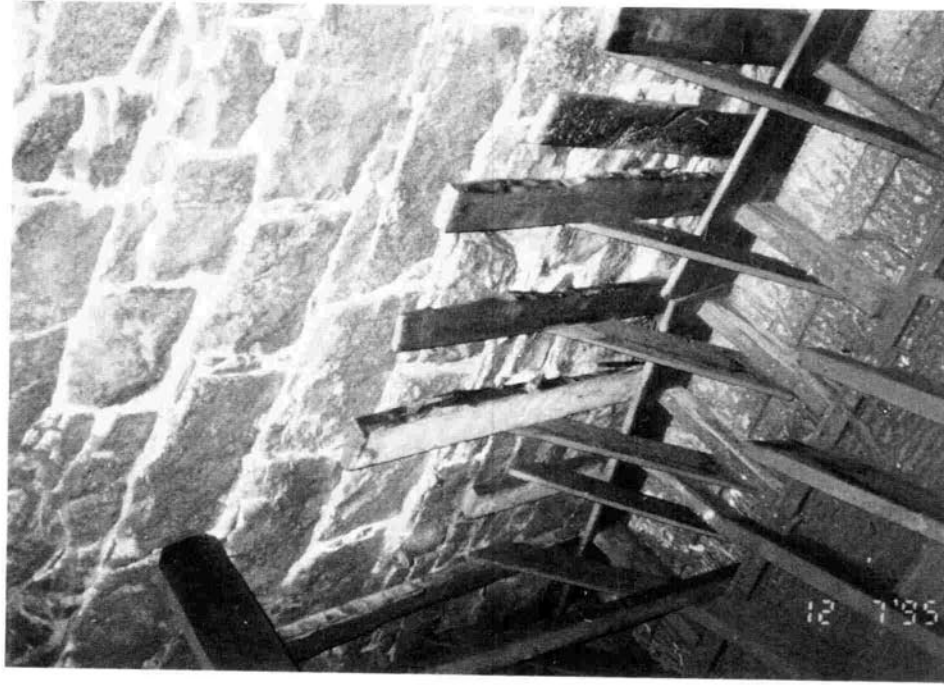
Figure 112. Church interior: attic, north end of east wall, at intersection with sanctuary ceiling. Note repointed mortar joints of wall.

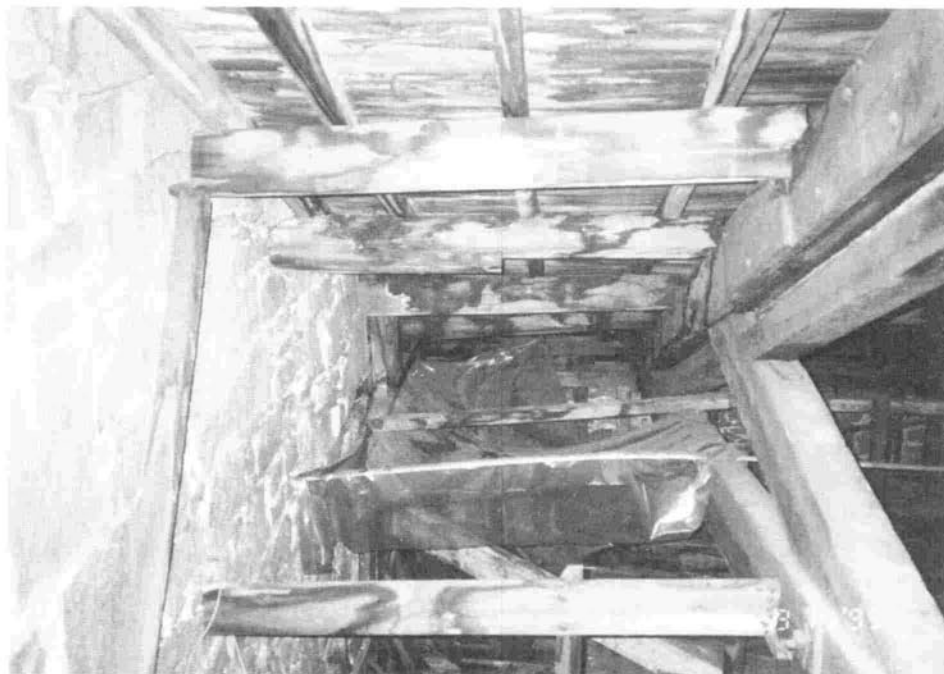
**Figure 113.** Church interior: attic, north end of west wall, at intersection with sanctuary ceiling.

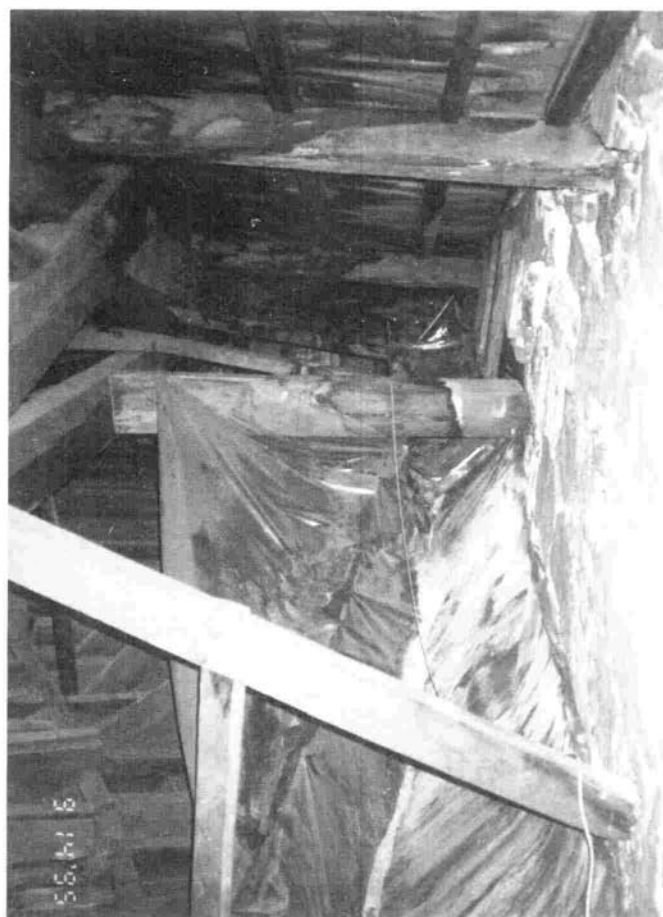
**Figure 114.** Church interior: attic, south end of west wall, at intersection with sanctuary ceiling.

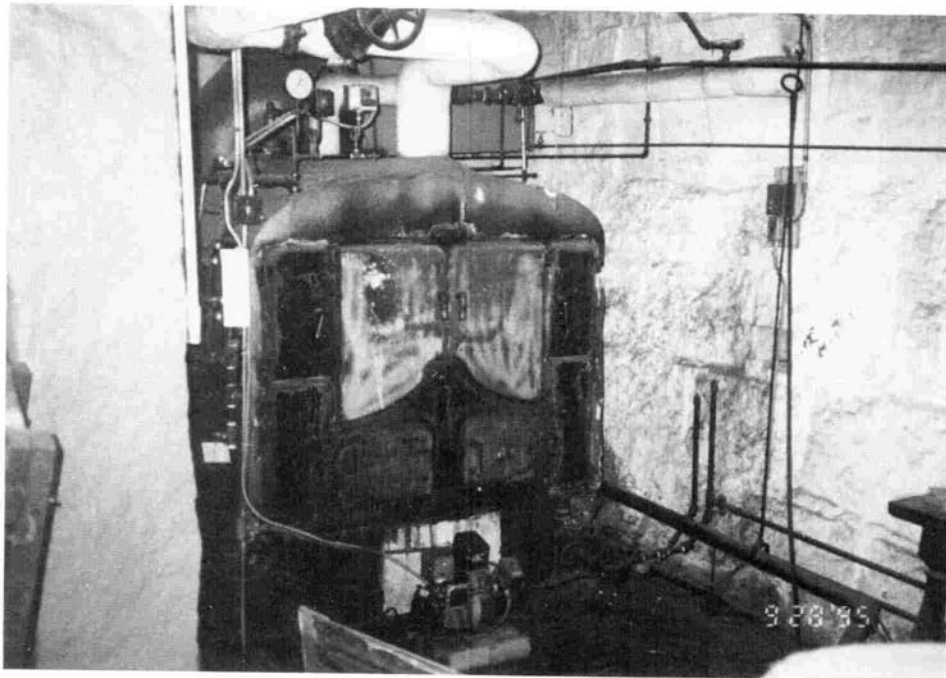
**Figure 117.** Church interior: basement furnace room.

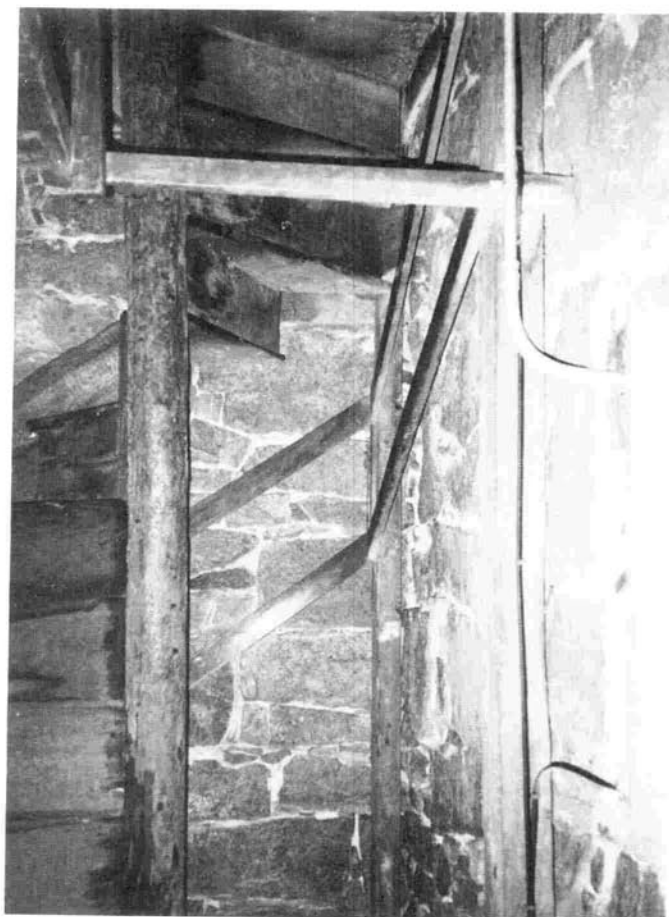
**Figure 118.** Tower interior: plinth room (Room 301),  
view northwest toward spiral staircase.

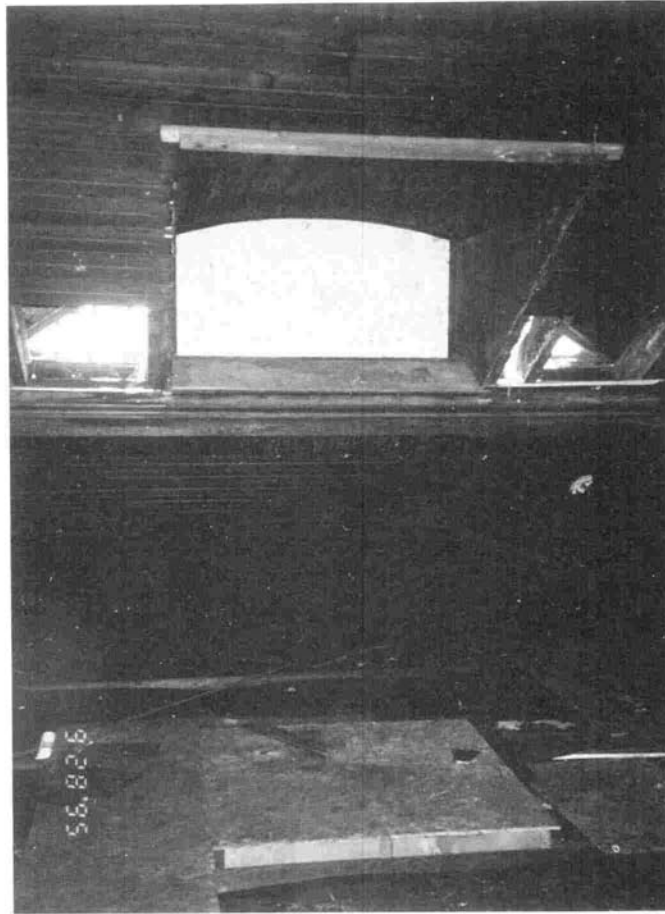
**Figure 121.** Addition interior: west attic (Room 204), south eyebrow window (W201).

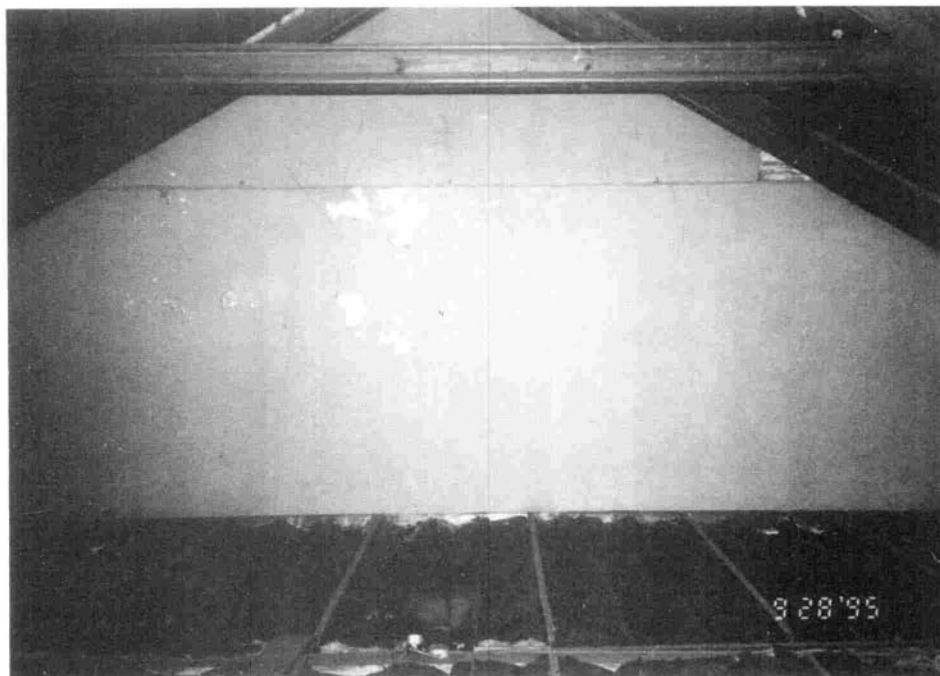
**Figure 122.** Addition interior: east attic (Room 205), west wall and suspended ceiling of the Parish Hall (Room 104) below.
